LAKE • GEORGE
WATERKEEPER®

Re: Blue Lagoon Resort (225.12-1-15)
Site Plan Review 41-2009

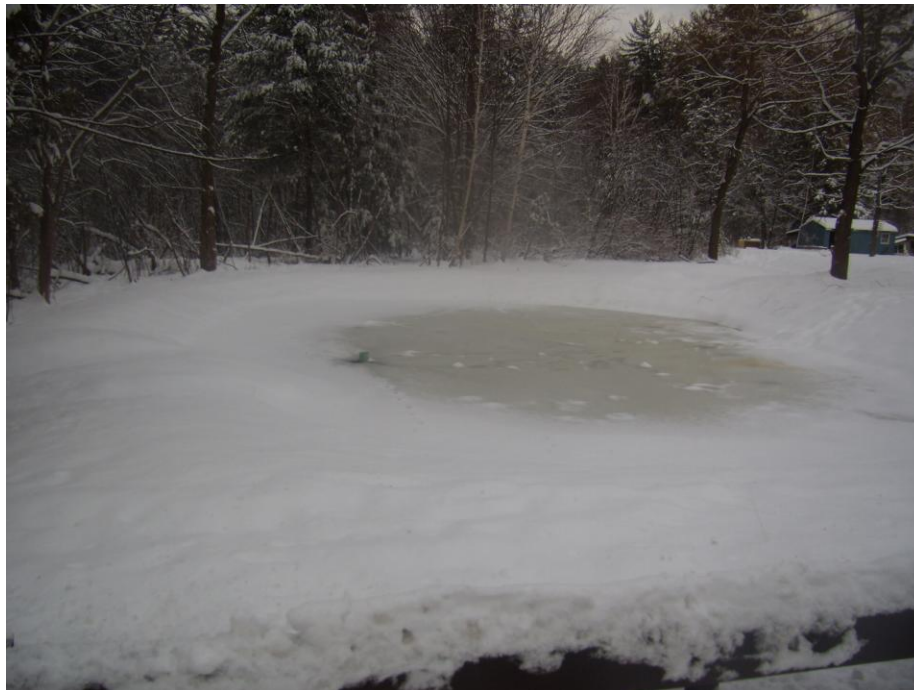
Photograph of wet pond constructed at the Blue Lagoon Resort. Note the standpipe on the left side of the pond and the ice elevation which reduces the ability for stormwater management.

- 1. The current pond is not constructed as per the approved plans.** Measures to protect water quality must be constructed as per the approved plans to prevent environmental impacts. The Lake George Waterkeeper maintains our opinion that wet ponds, which cannot infiltrate stormwater, do not meet the post-construction volume reduction requirements of the Town of Lake George Code despite the signoff by the Town Engineer. The failure to construct the system according to the approved plans further increases negative impacts to the environment.

The Lake George Waterkeeper recommends the Town of Lake George Planning Board condition the site plan with a requirement for further review of the stormwater management facility that will also manage stormwater runoff from the accessory structure, specifically to require a certification of construction and evaluate increasing the level of stormwater treatment and management. This will improve water quality from the impervious surfaces located adjacent to a tributary in close proximity to Lake George. Any revisions to a major stormwater management plan should be required to resubmit plans to the Planning Board.

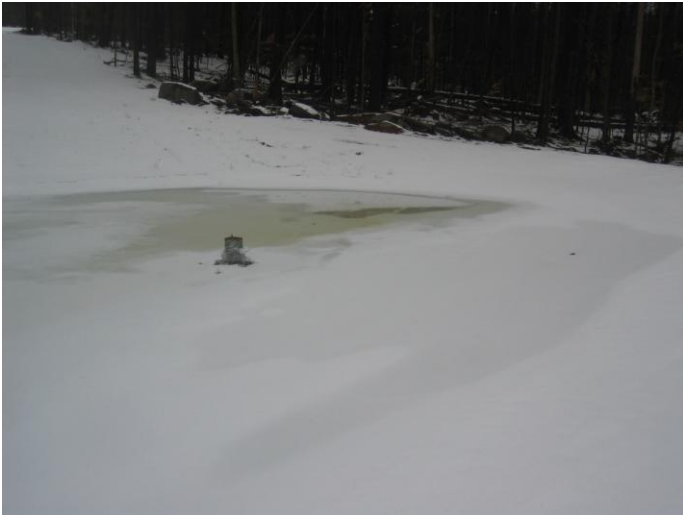
Photograph of wet pond - Town of Hague subdivision taken on January 30, 2008. Note the freeboard height of the standpipe above the ice elevation.

2. The stormwater management facility will be greatly impacted by cold climate conditions resulting in negative impacts to water quality. Wet ponds are significantly impacted by cold climate conditions through freezing of the permanent pool elevation, resulting in ice accumulation that reduces the storage volume available. Storage volume is reduced to a point where no storage is available and therefore, there is no stormwater management. In northern climates, this can result in no stormwater management for periods of 4-5 months. The wet pond at the Blue Lagoon Resort has already developed ice within 6" of the emergency spillway elevation. Please refer to the attached photograph. In addition, please refer to a group of photographs demonstrating the volume reduction from ice buildup over the winter of a wet pond in the Town of Hague.

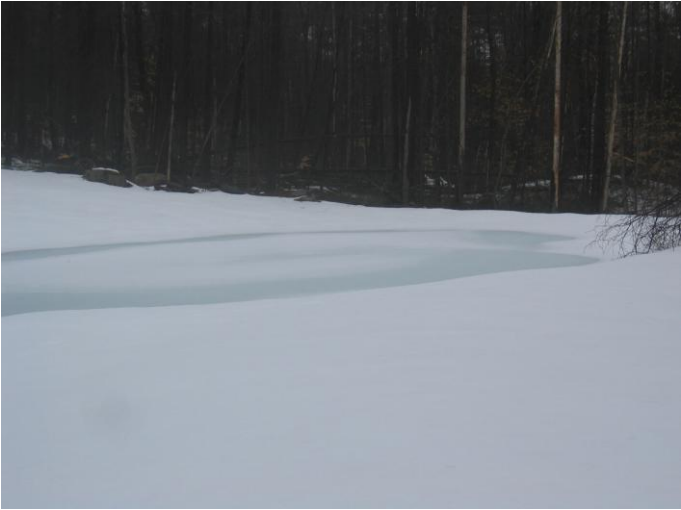
Photograph of same wet pond – Town of Hague subdivision taken on March 20, 2008. Note that there is no freeboard on the standpipe above the ice resulting in direct discharge of runoff without management or treatment.

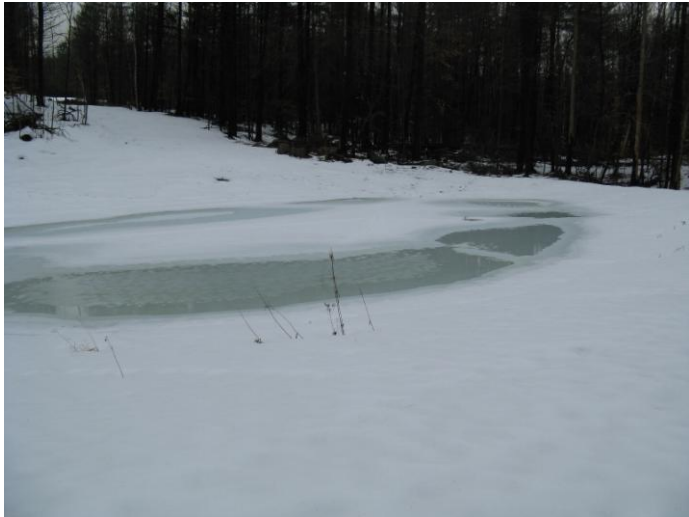
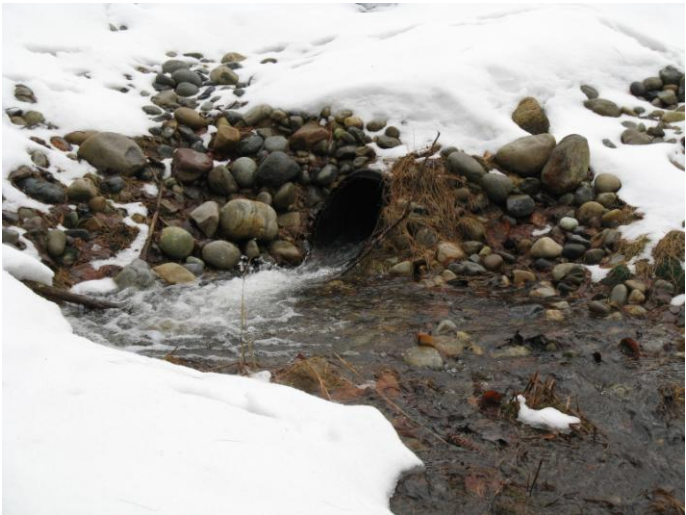
Photograph of same wet pond taken on March 11, 2009 during rain event. Note the lack of freeboard on standpipe resulting in direct discharge of runoff during rain event show in adjacent photograph.
